MID-AIR

It's 10 years since the world's deadliest mid-air collision. Macarthur Job reviews major mid-air accidents over the past decade, and looks at how technology has been used to prevent further collisions.

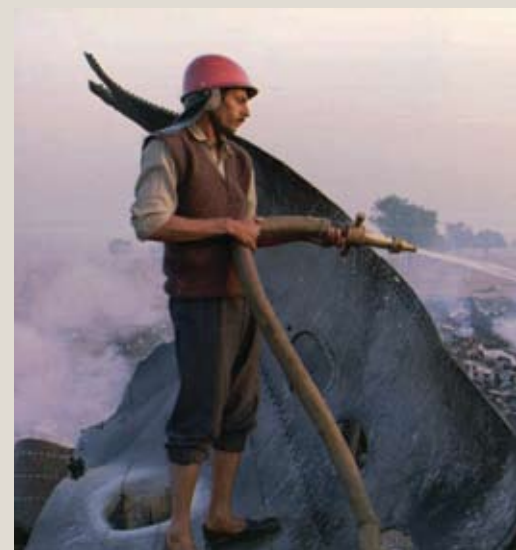
Disaster debris: A fireman sprays water over the smouldering debris of the Saudi B747 which collided mid-air with an Air Kazakhstan cargo plane killing 349 people on November 12, 1996, near the town of Charkhi Dadri, about 100km west of New Delhi. The Saudi

airliner was climbing after takeoff from New Delhi airport when it collided with the Kazakhstan aircraft coming in for landing. The wreckage was strewn across 10km of wheat and mustard fields.

In an arid, flat farming area, thinly populated with small villages, 100km west of Delhi Airport, witnesses saw "a fireball" and "thick black smoke" falling to the ground. The main wreckage of both aircraft fell into open cotton and mustard fields several kilometres apart, that of the 747 narrowly missing a tiny village. Scattered between the two impact sites lay debris from both aircraft. No-one on the ground was injured.
